Overview:

The use of multi-constellation GNSS receivers has been assumed as a way to increase system integrity both by increased coverage during normal operations and fail-over redundancy in the event of a constellation failure. At approximately 21:00 UTC on April 1st the entire GLONASS constellation was disrupted as illegal ephemeris uploaded to each satellite took effect simultaneously. The outage continued for more than 10 hours as affected satellites broadcast navigation messages with incorrect application times.

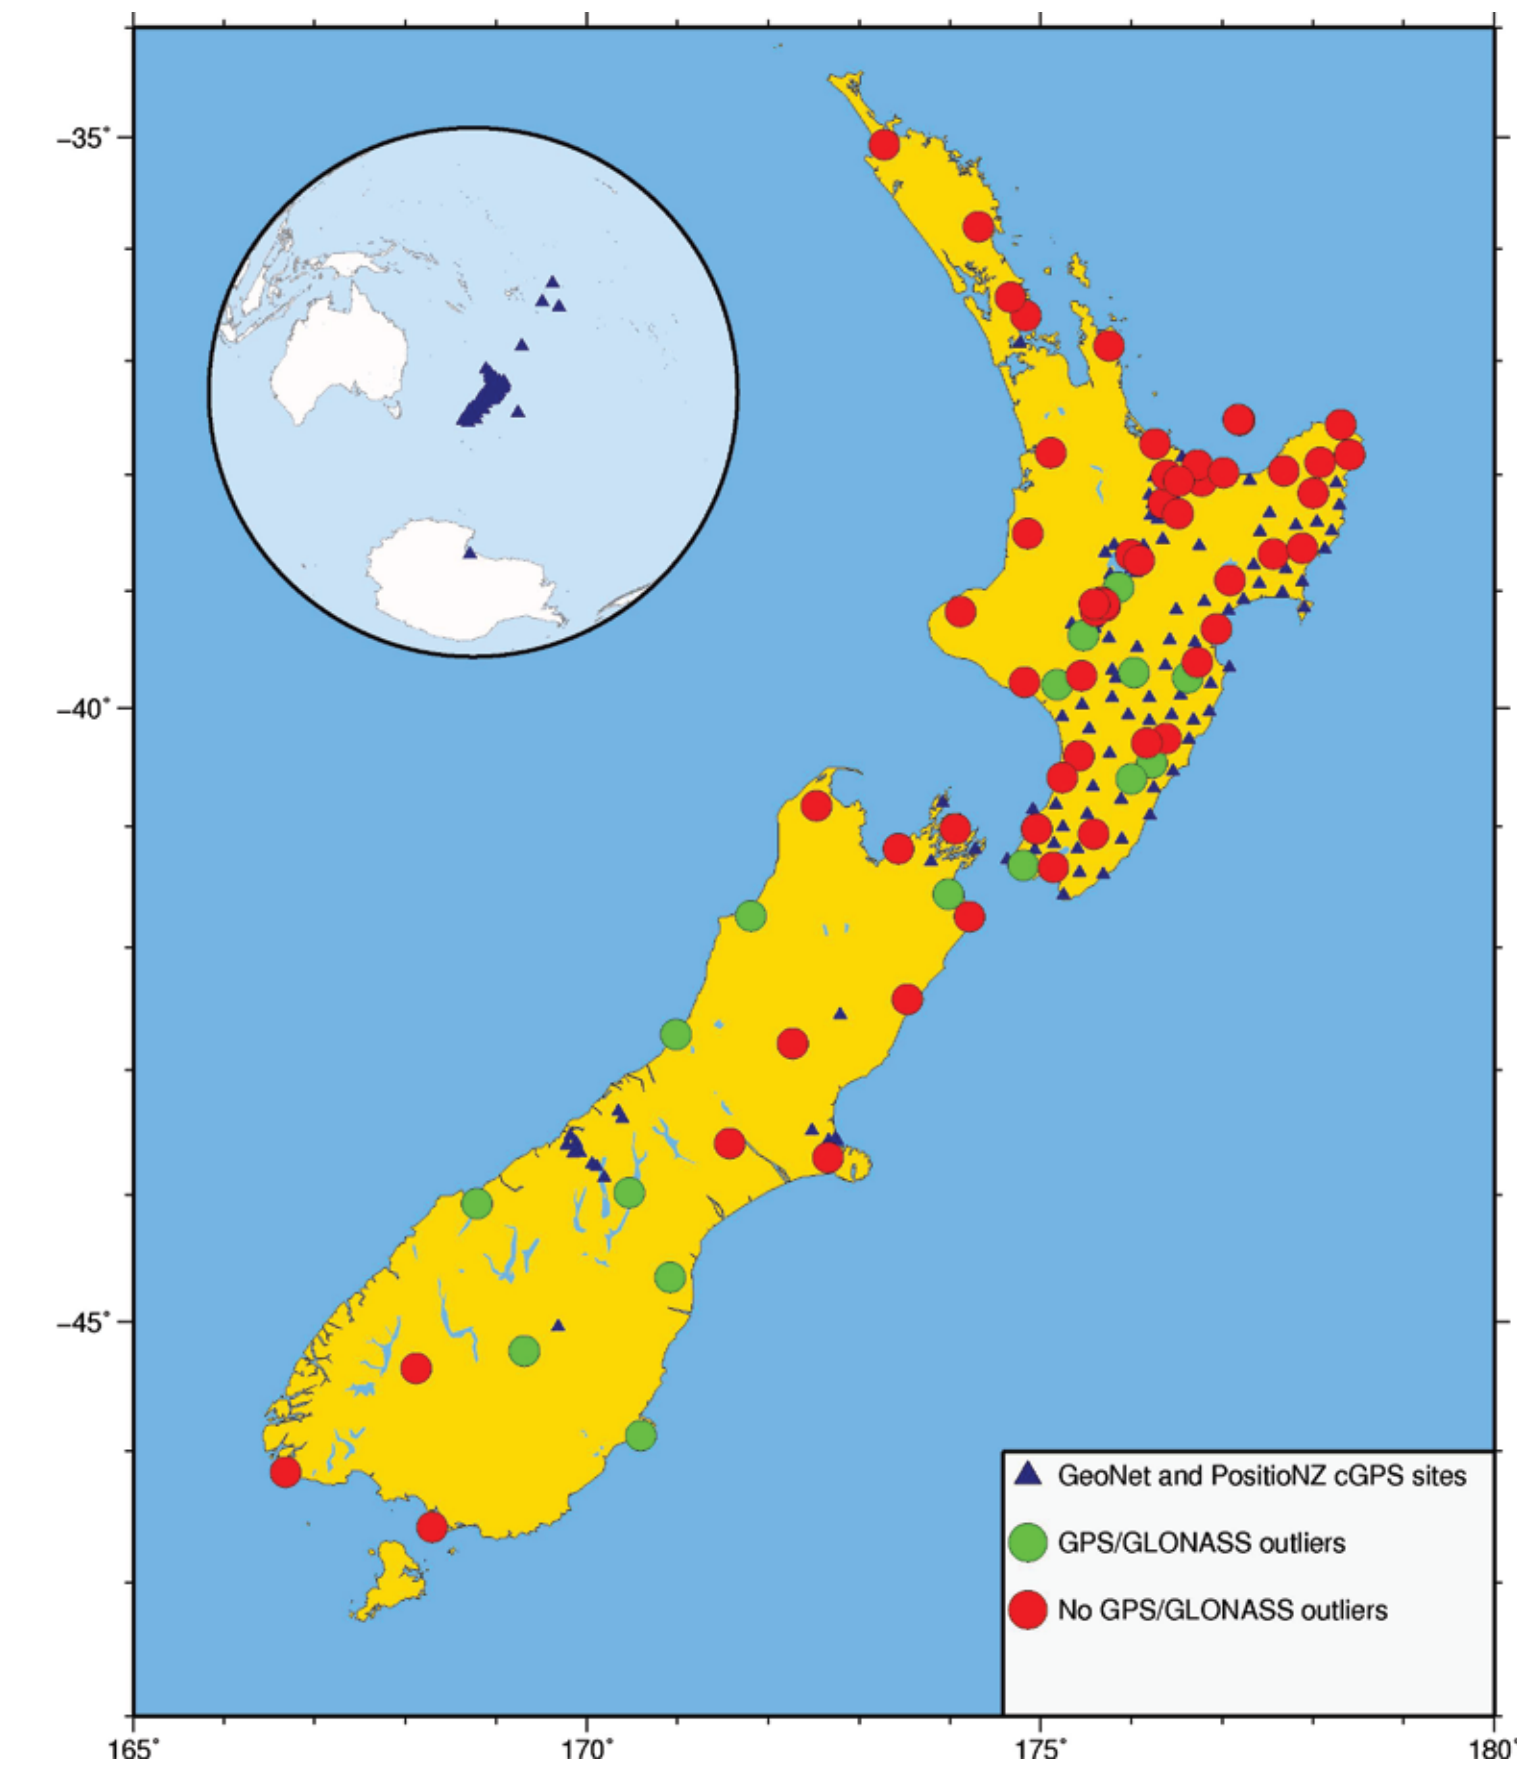
Observations from the GeoNet network in New Zealand indicate that a significant percentage of the 79 GLONASS-enabled receivers experienced total tracking failures during the outage period, which caused real-time streaming outages and data loss. Network operators disabled GLONASS tracking on a subset of receivers that were streaming RTCM messages. The receivers immediately returned to normal tracking behavior after GLONASS was disabled.

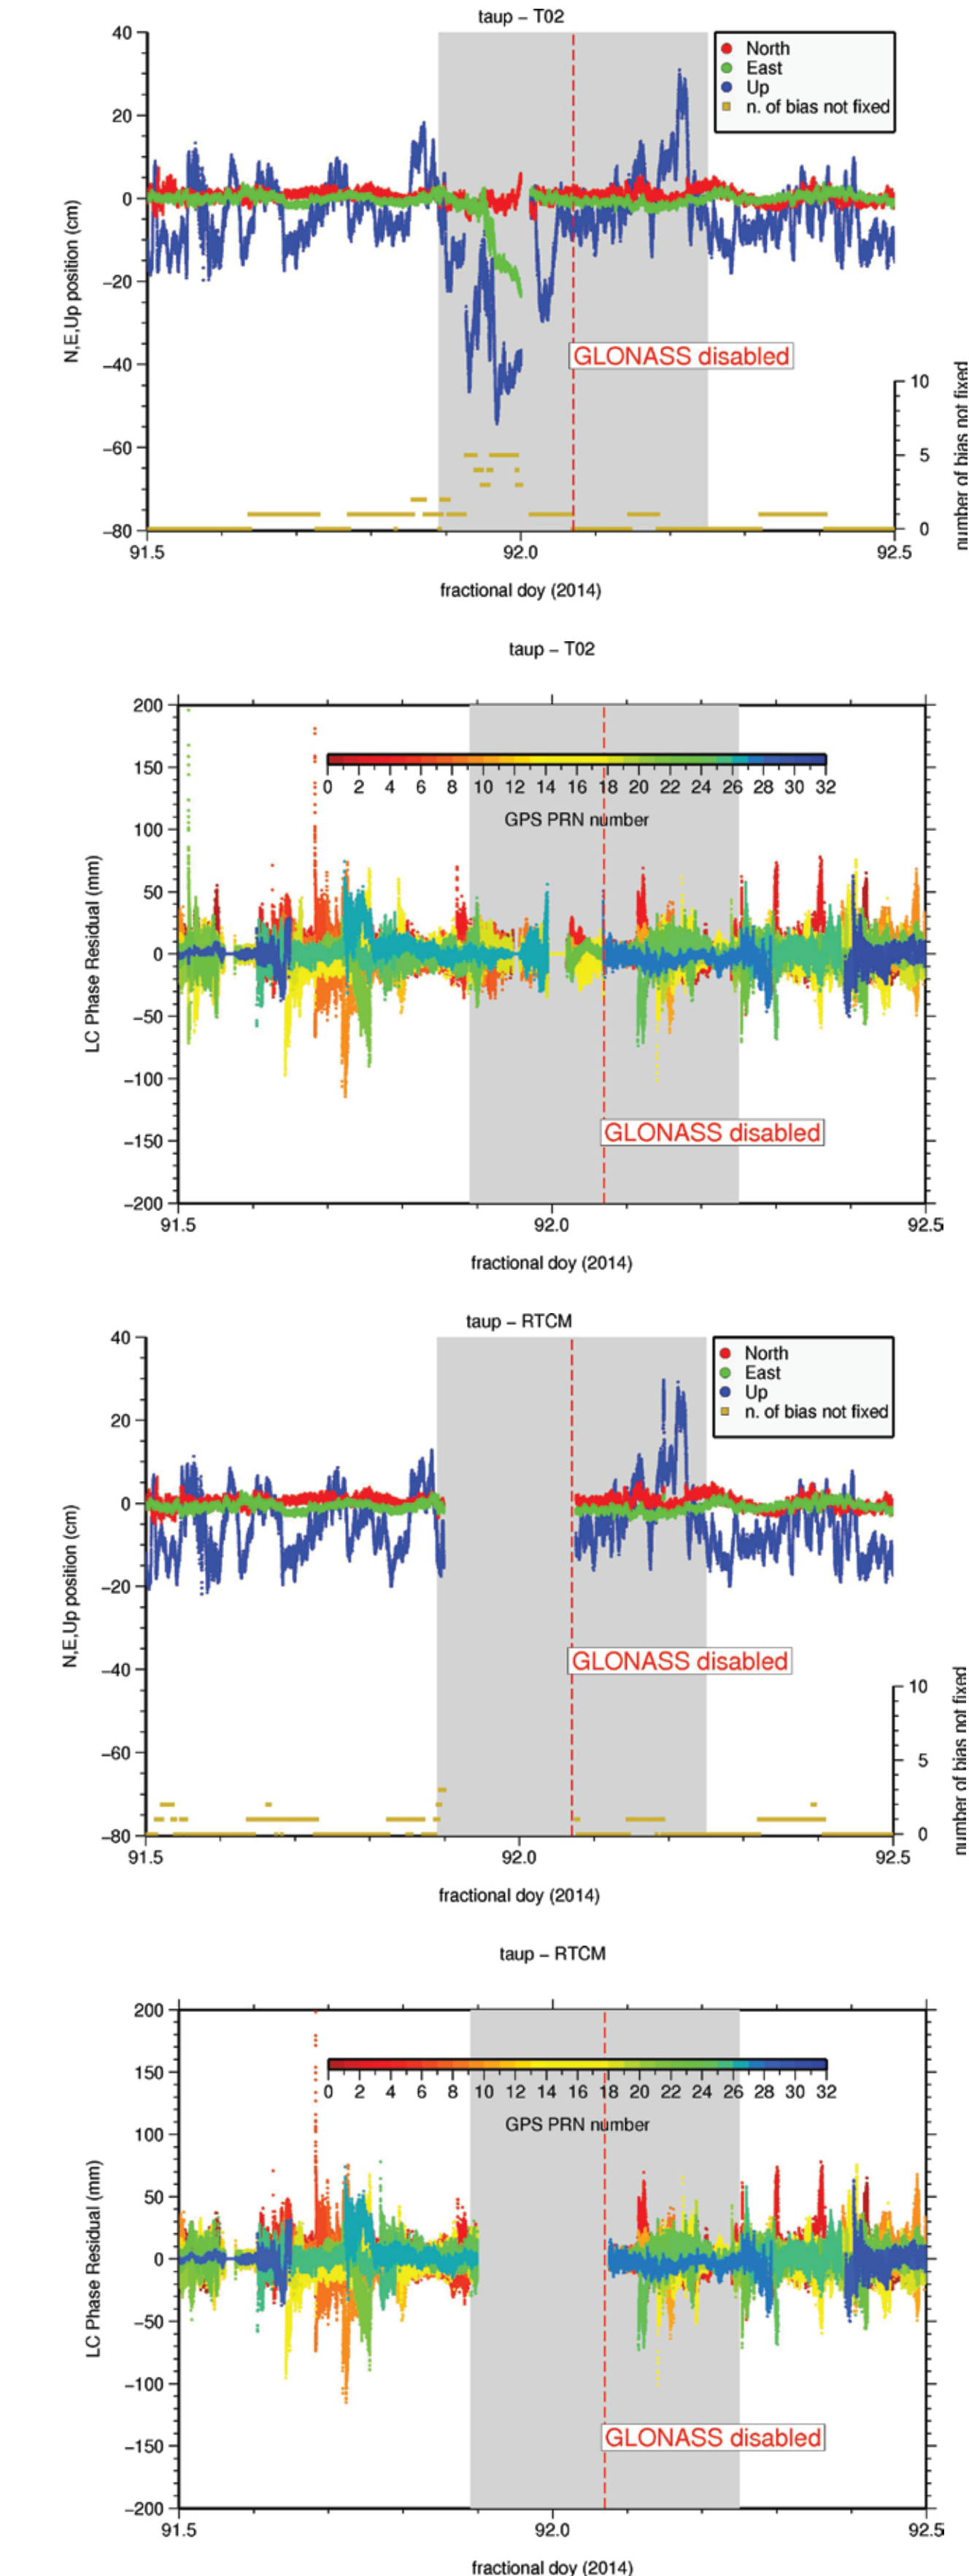
GeoNet - Track Results

These figures show processing results from the station TAUP in New Zealand's Geonet. The upper two figures show processing results from the raw T02 files. The lower two figures show the processing results from data collected via RTCM streams. The outage affected the RTCM processing up to the time when GLONASS tracking was disabled.

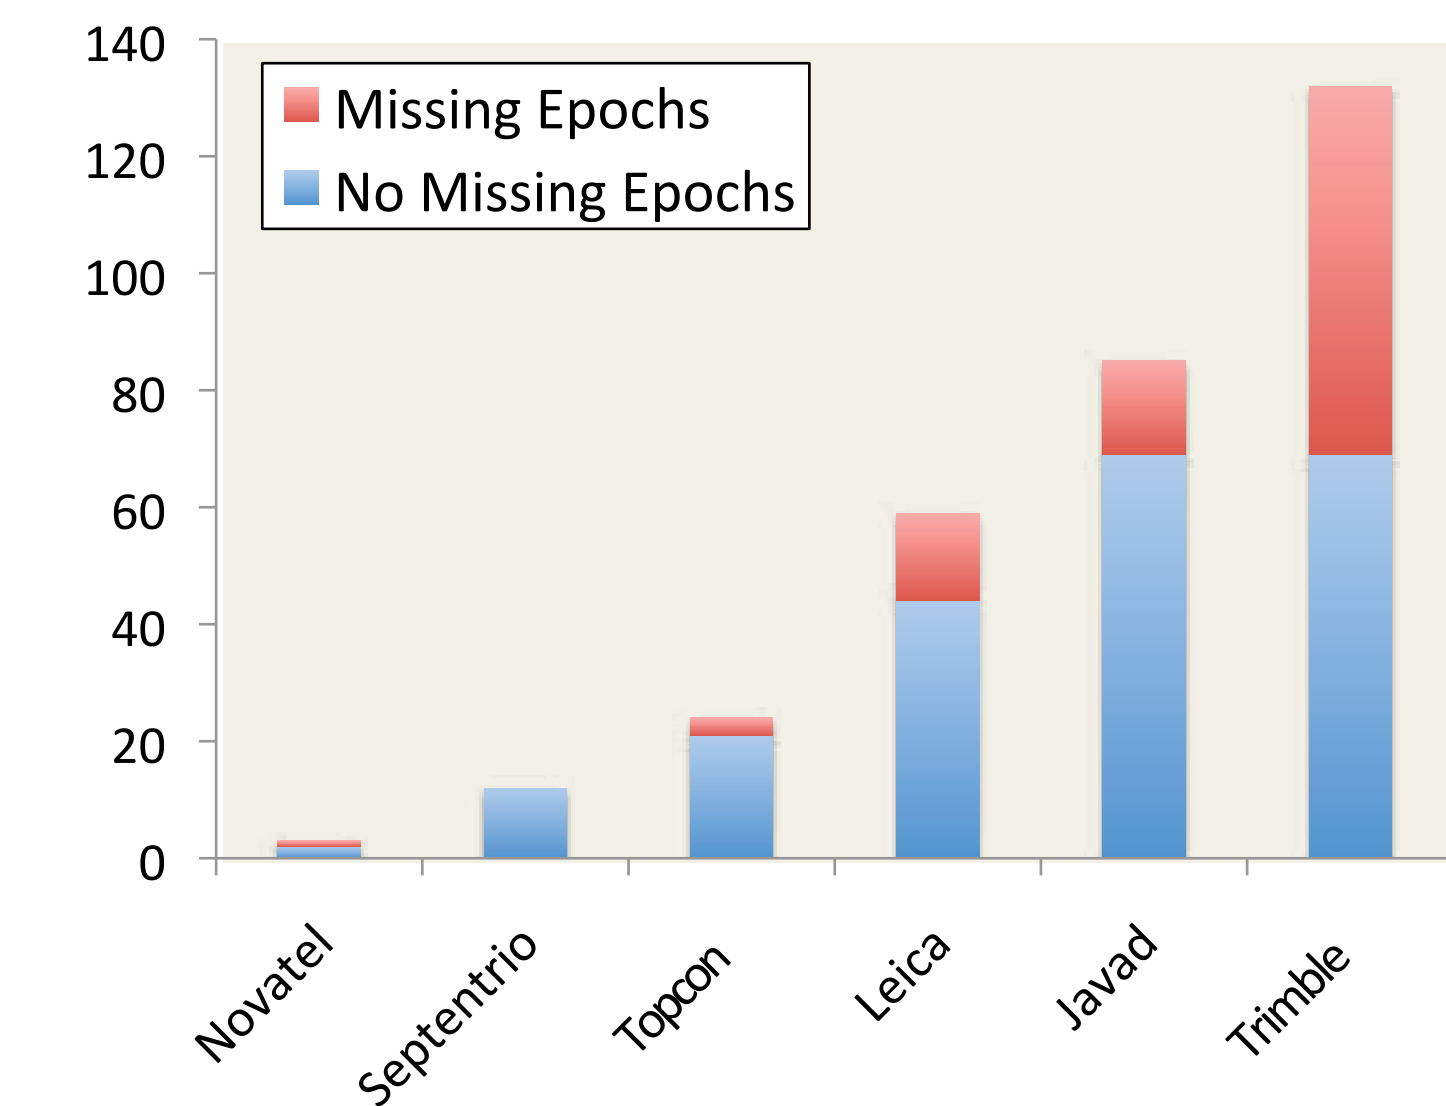
Receivers

Sites were flagged as missing epochs if the predicted number of epochs did not match the number recorded in the UNAVCO archive. The results have been organized by receiver make.

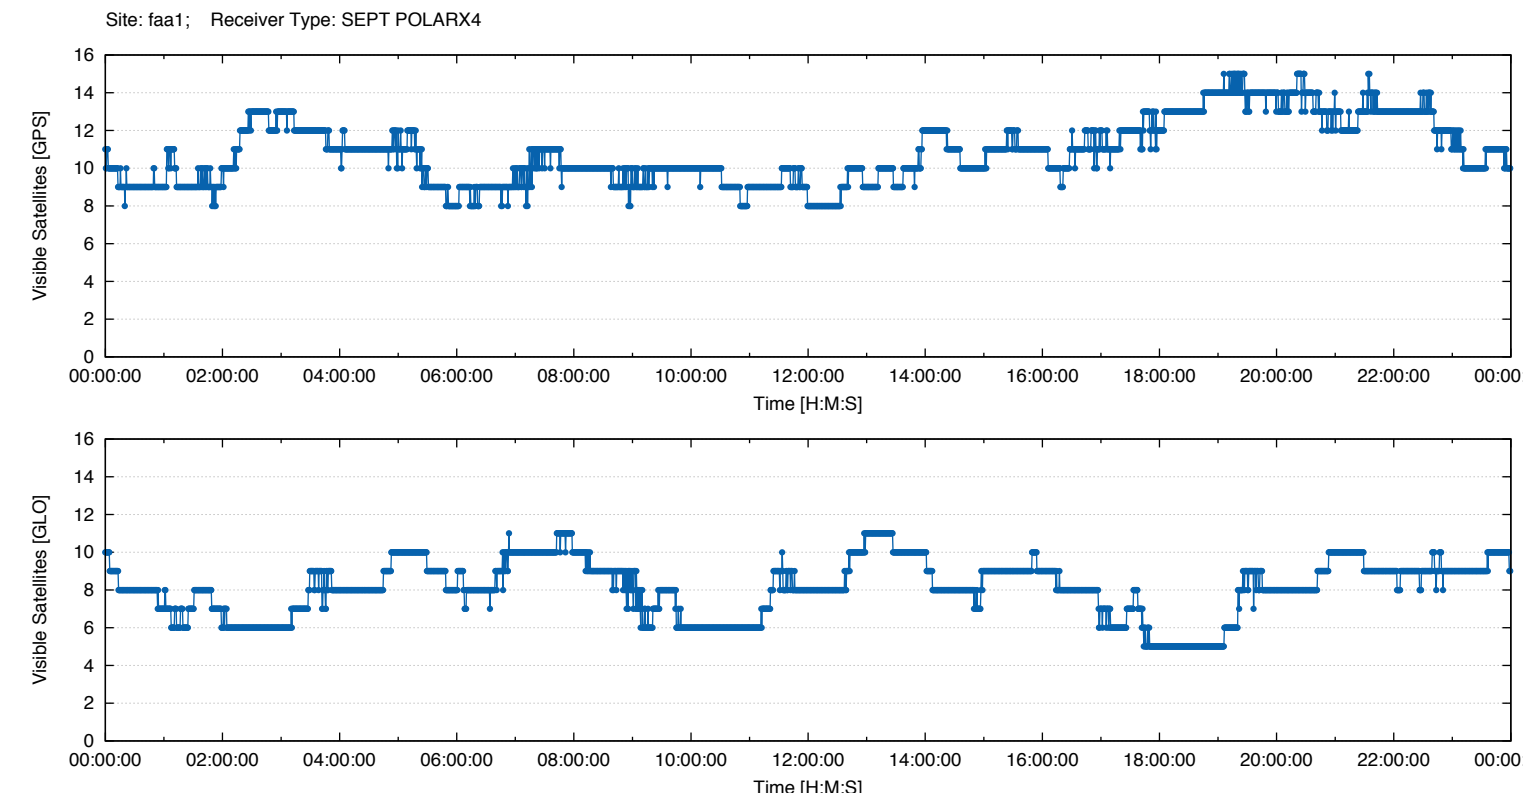
Some sites continued tracking throughout the outage:

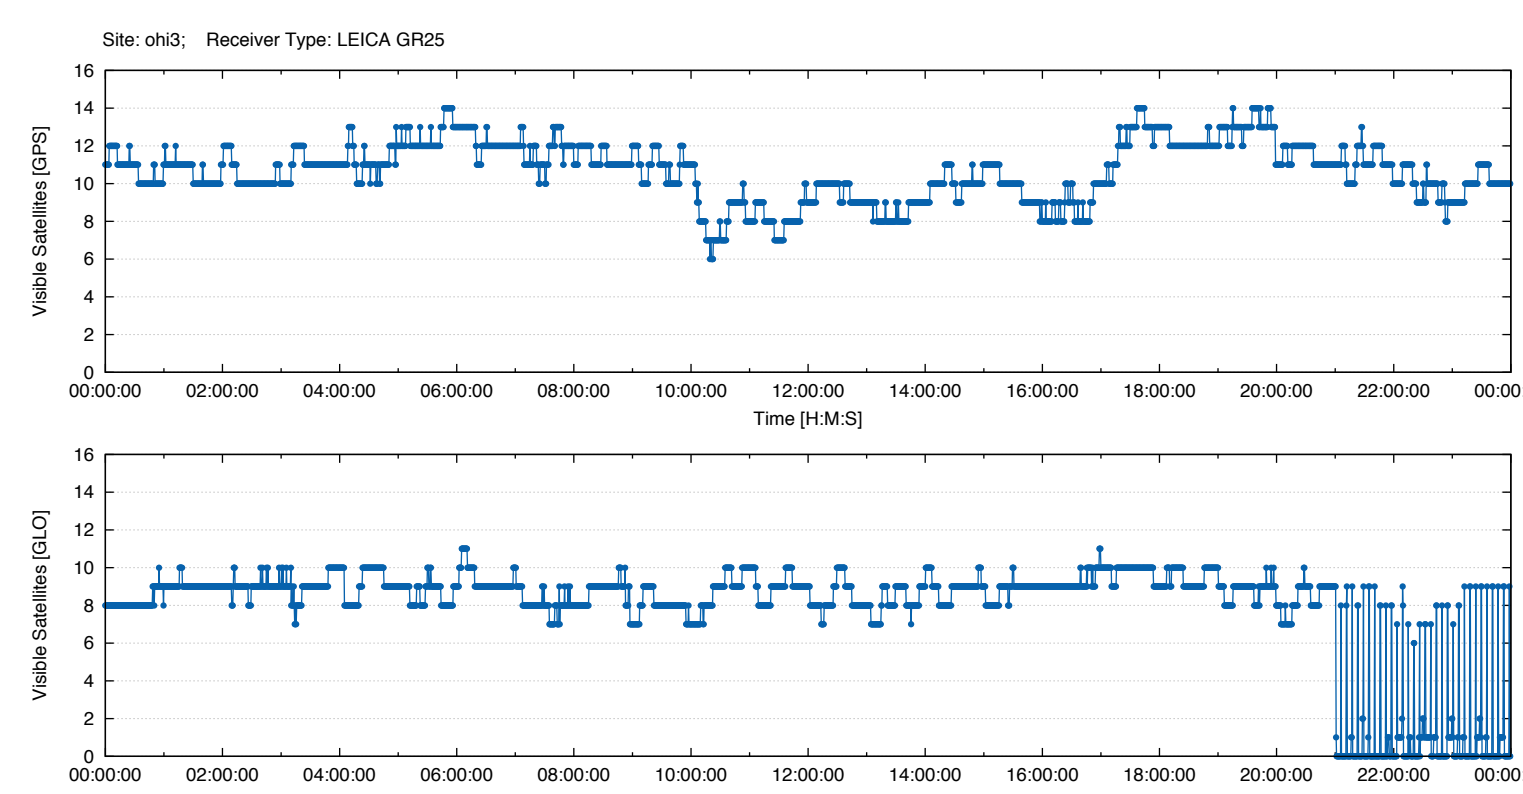
Some sites exhibited tracking problems only with GLONASS:

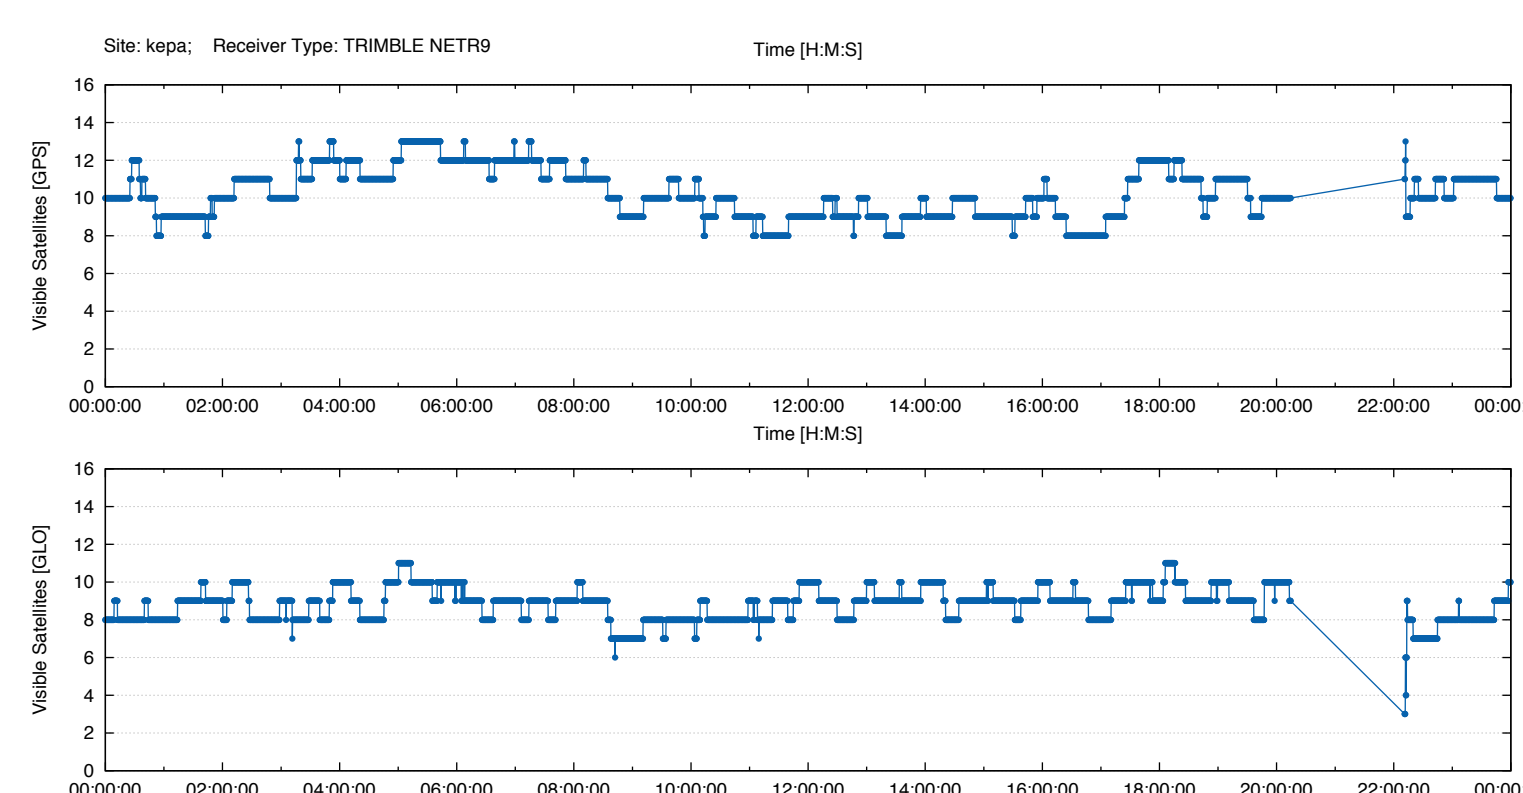
While other sites had complete tracking failures on all satellites:

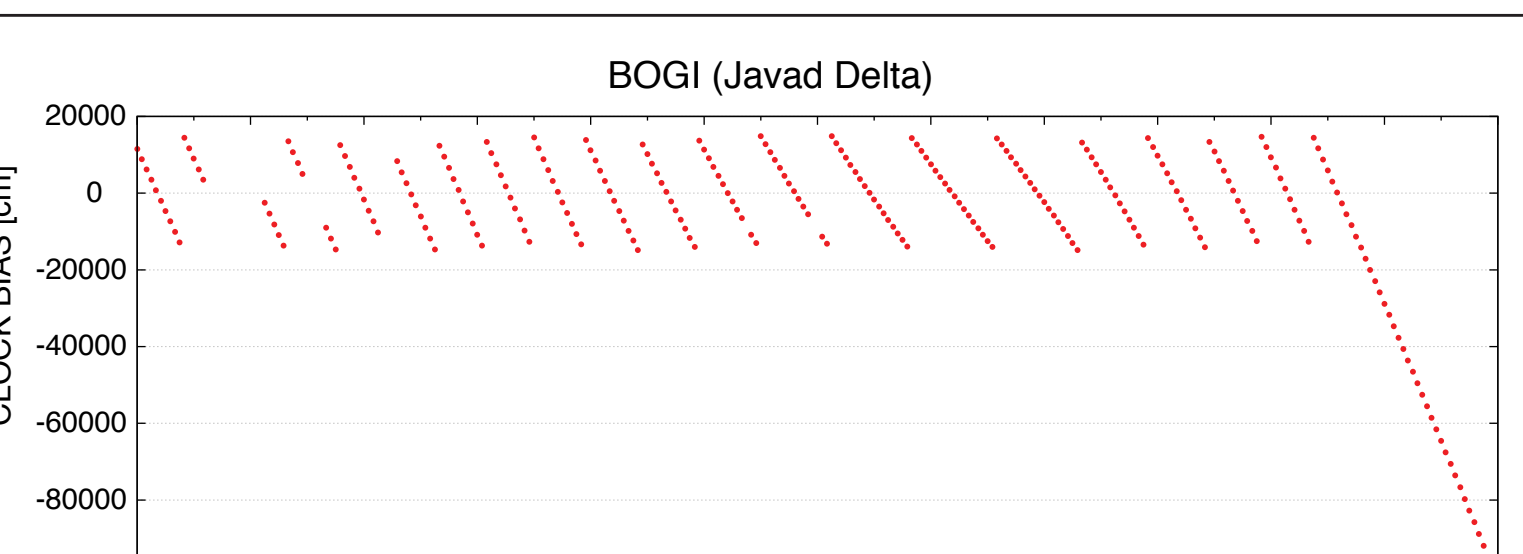
Clock bias estimates as computed by GIPSY-OASIS for the station BOGI on day 91 of 2014. Clock steering on this Javad Delta receiver stopped functioning correctly following the beginning of the outage at 21:00 UTC. The clock steering did not recover until the receiver was rebooted on day 92.

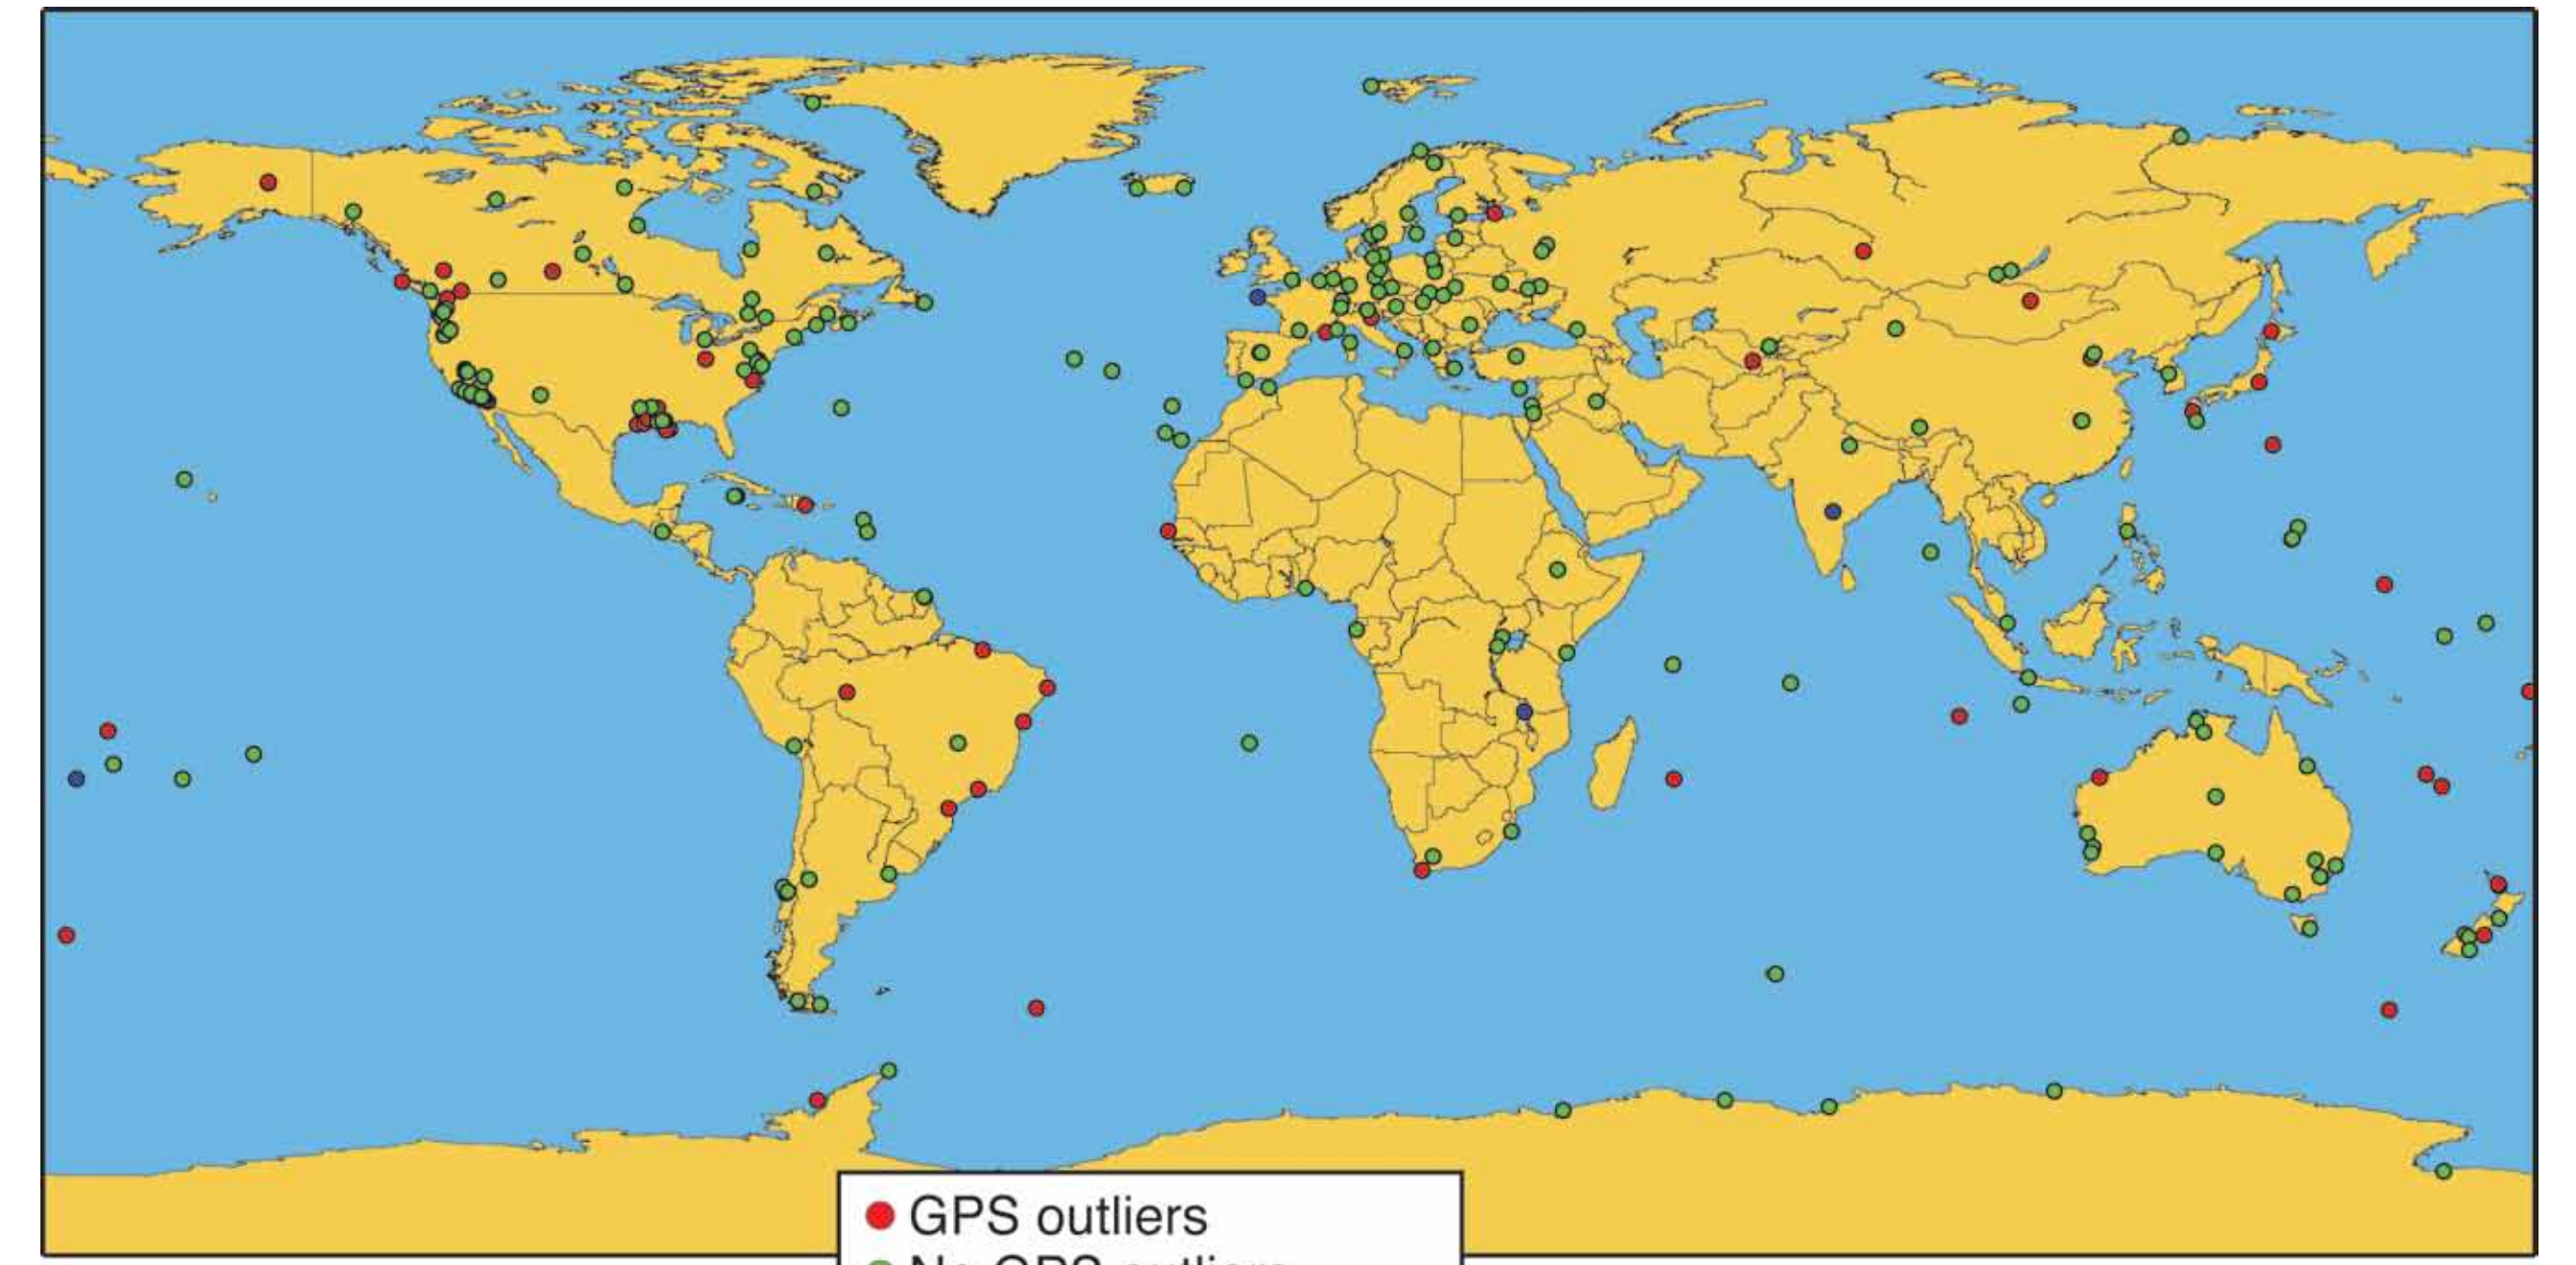
GPS Outliers

Aggregated data from 316 sites in the UNAVCO archive that were tracking GLONASS at the time of the outage. The GPS outlier flags were determined from missing epochs and by manual inspection of visible satellites figures. We found that 67 of the 316 sites (21%) had some problems tracking GPS during the outage.

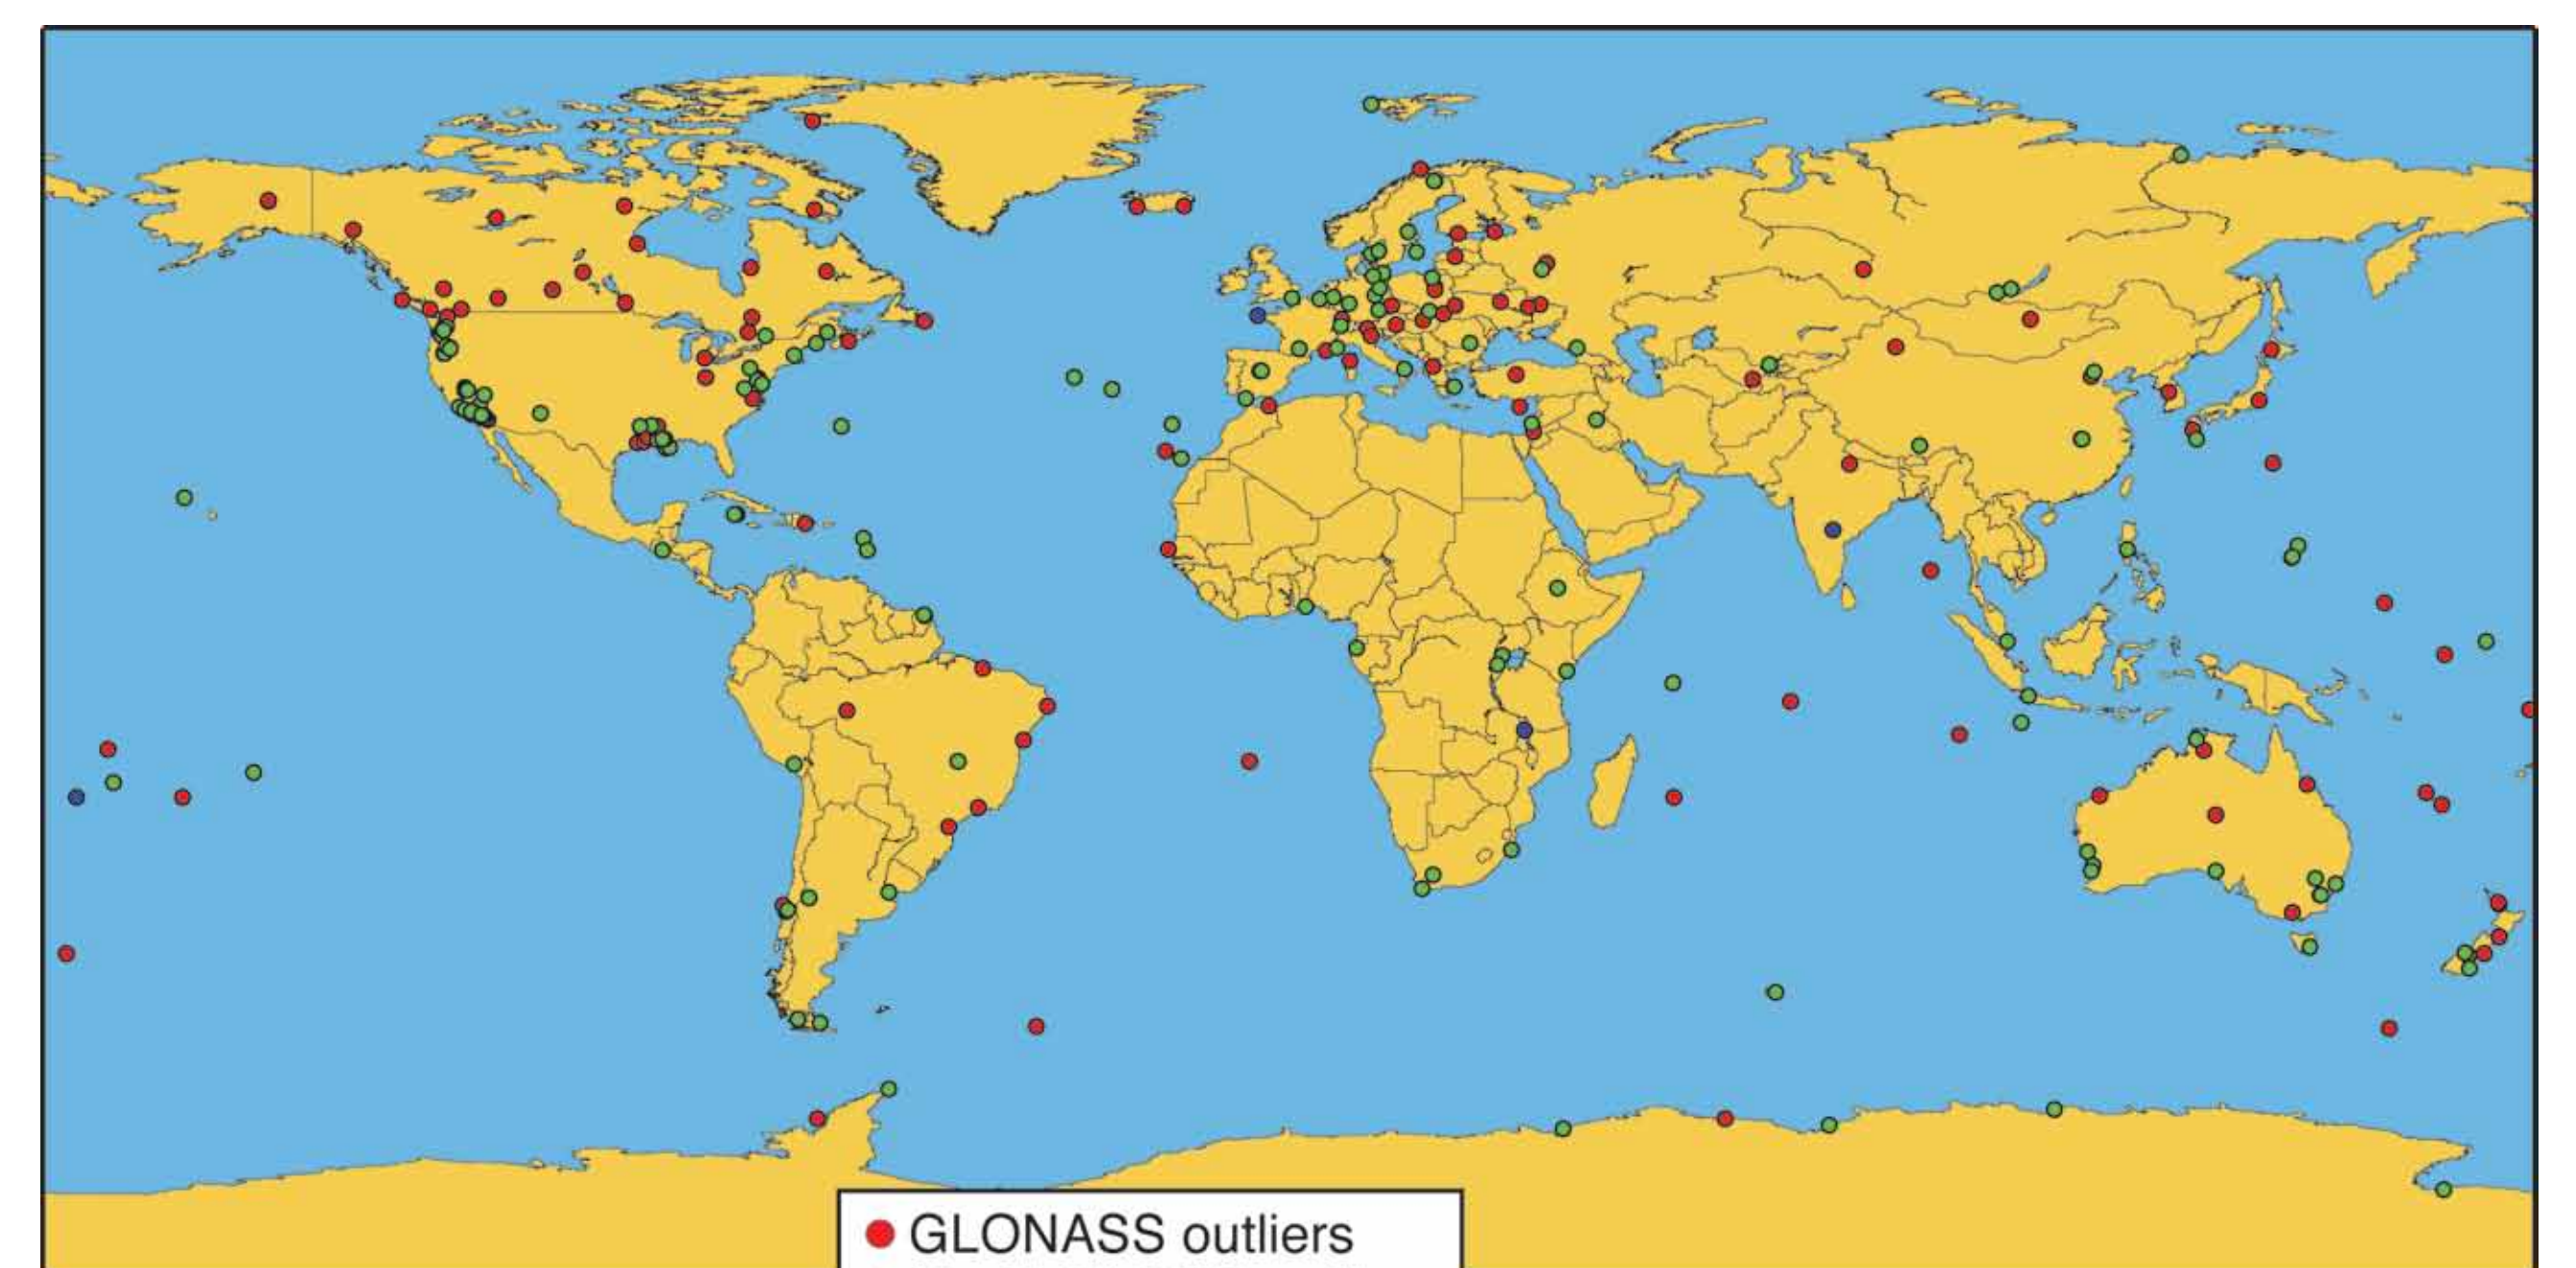
GLONASS Outliers

Aggregated data from 316 sites in the UNAVCO archive that were tracking GLONASS at the time of the outage. The GLONASS outlier flags were determined from missing epochs and by manual inspection of visible satellites figures. We found that 131 of the 316 sites (41%) had some issue tracking GLONASS during the outage.

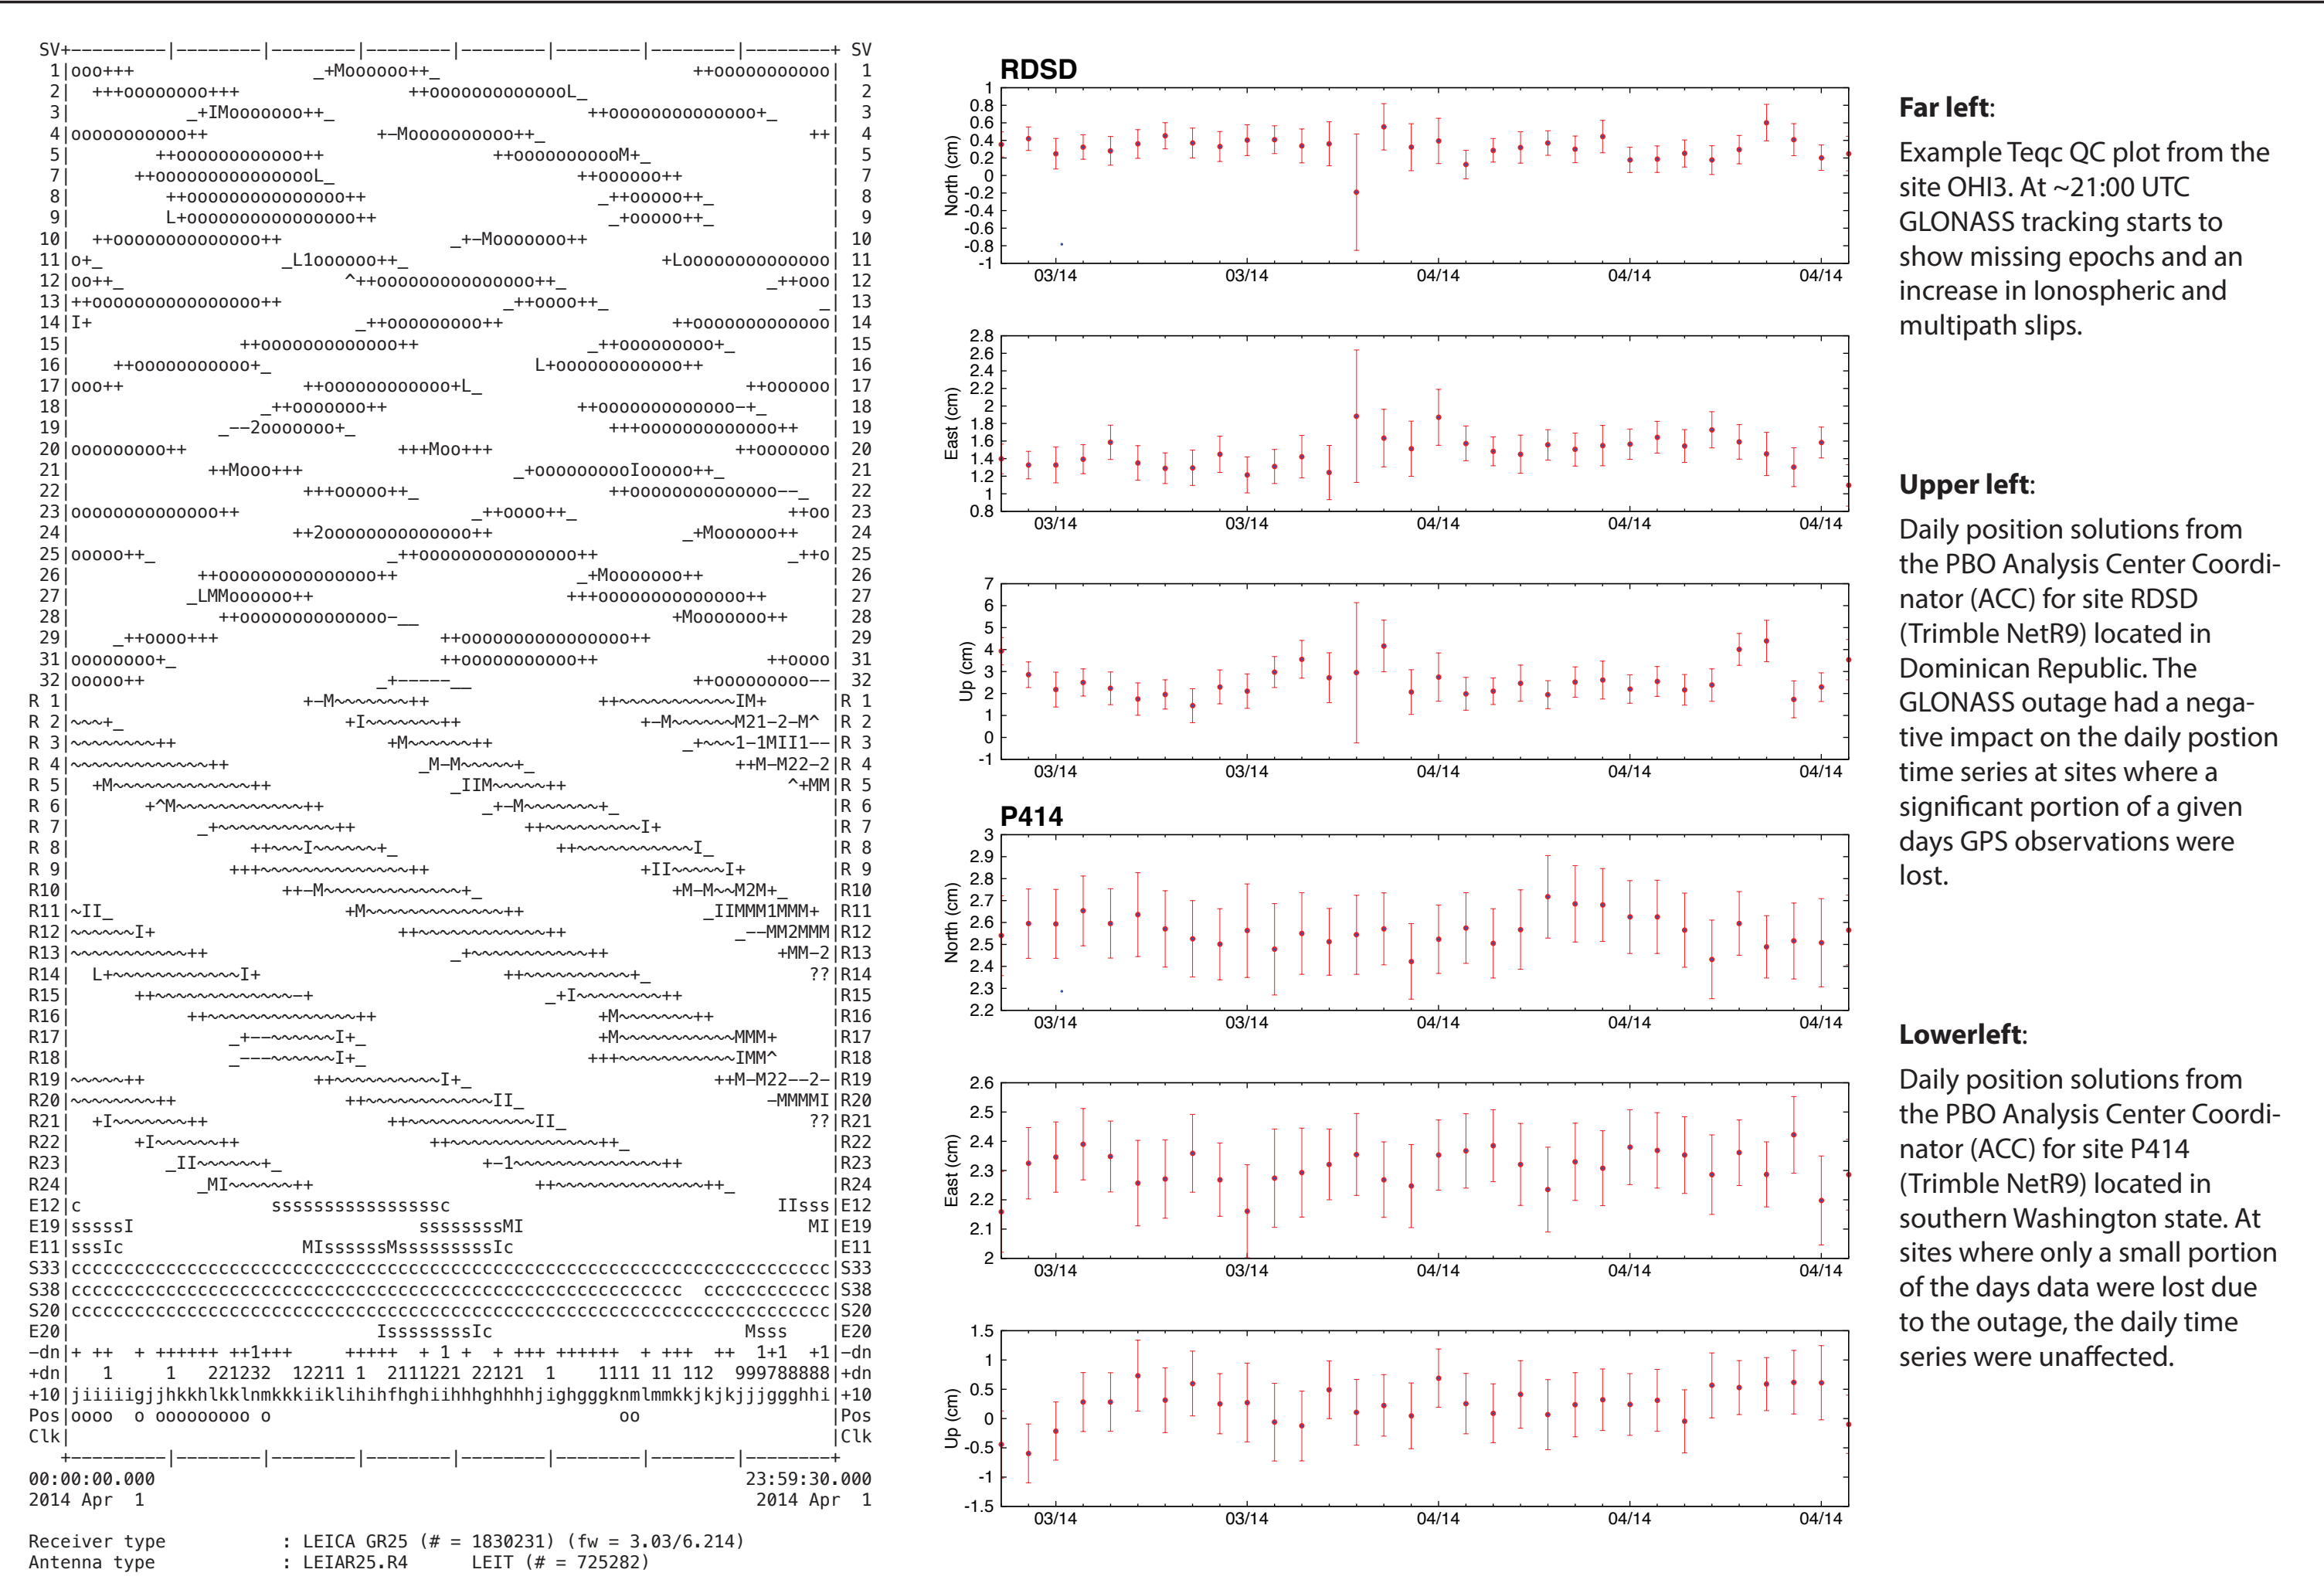
Far left: Example Teqc QC plot from the site OH13. At ~21:00 UTC GLONASS tracking starts to show missing epochs and an increase in ionospheric and multipath slips.

Upper left: Daily position solutions from the PBO Analysis Center Coordinator (ACC) for site RDSO (Trimble NetR9) located in Dominican Republic. The GLONASS outage had a negative impact on the daily position series at sites where a significant portion of a given days GPS observations were lost.

Lower left: Daily position solutions from the PBO Analysis Center Coordinator (ACC) for site P414 (Trimble NetR9) located in southern Washington state. At sites where only a small portion of the days data were lost due to the outage, the daily time series were unaffected.
