Overview:

The use of multi-constellation GNSS receivers has been assumed as a way to increase system integrity both by increased coverage during normal operations and fail-over redundancy in the event of a constellation failure. At approximately 21:00 UTC on April 1st the entire GLONASS constellation was disrupted as illegal ephemeris uploaded to each satellite took effect simultaneously. The outage continued for more than 10 hours as affected satellites broadcast navigation messages with incorrect application times.

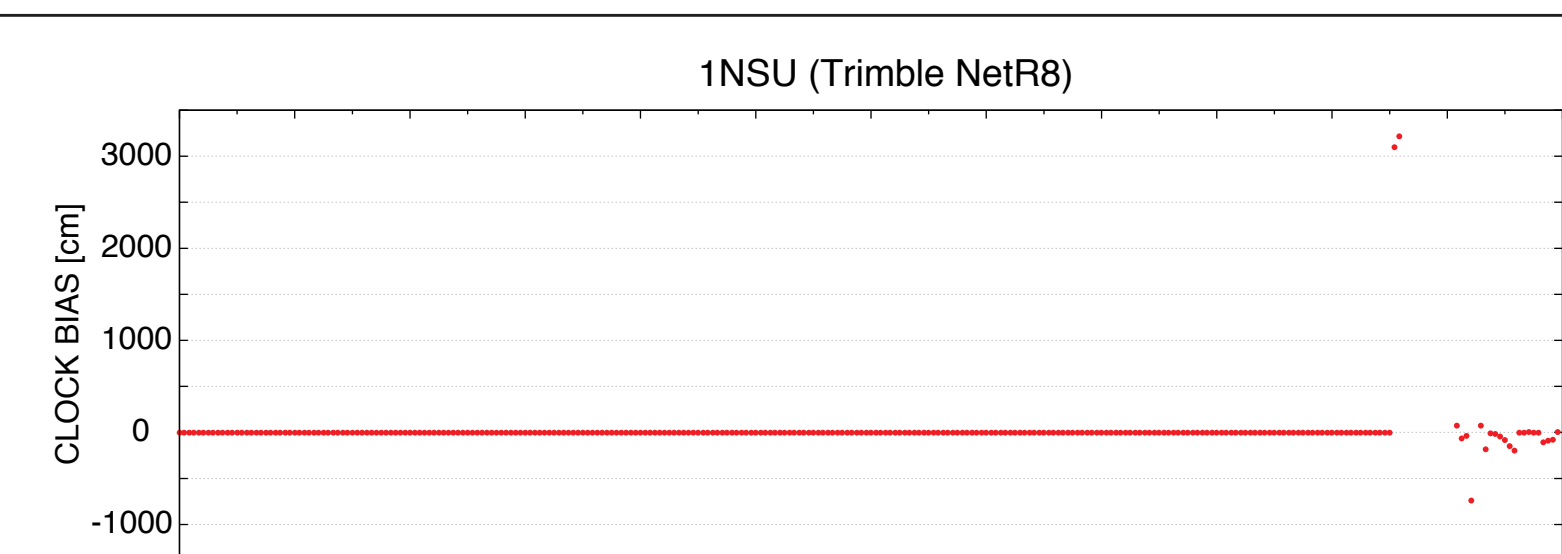
Clock bias estimates as computed by GIPSY-OASIS for the station 1NSU on day 91 of 2014. Clock steering on this Trimble NetR8 receiver exhibited large outliers following the beginning of the outage at 21:00 UTC. The increased clock noise did not stop until the end of the GLONASS outage on the following day.

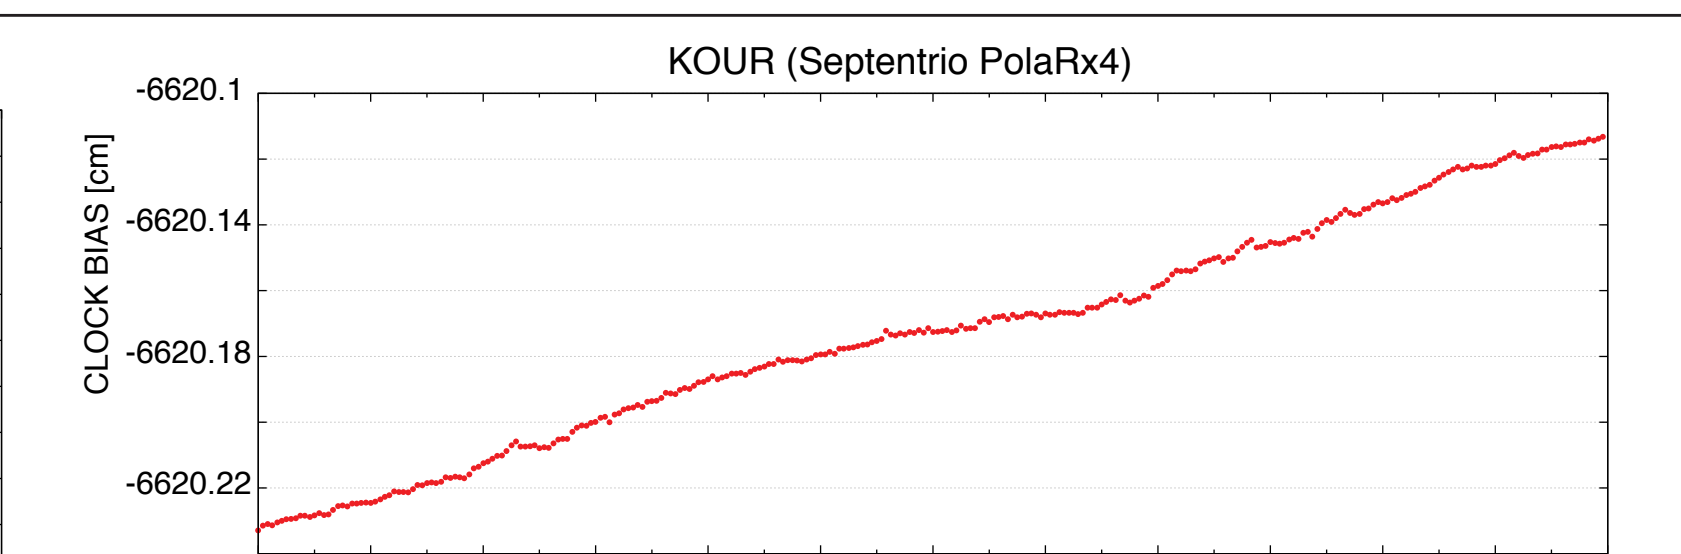
Clock bias estimates as computed by GIPSY-OASIS for the station KOUR on day 91 of 2014. The internal clock at this station is slaved to an external H-maser and the receiver does not apply any clock steering. This Septentrio PolaRx4 receiver continued to function nominally throughout the outage. We observed nominal tracking of GPS and GLONASS at the majority of sites where a superior external reference was used instead of the internal clock.
